THE PORTICO OF THE CHURCH OF ST. FRANCIS IN URBINO: A DIGITAL MAP FOR MONUMENTS

This paper describes the preliminary study for restoration works on the portico of the Church of St. Francis in Urbino. The aim of this study is to develop models used for restoration works on the surfaces of the portico, based on a prior architectural survey using different methodologies. The research project was carried out in 2 phases: during the first phase quantitative data were obtained by means of formal-geometric surveys and during the second phase qualitative data were obtained by developing models. Results were diversified according to needs and the methods used in order to create a “digital map of the monument“ in its context. In the last phase, the various methodologies were analysed and compared in order to evaluate their accuracy, convenience (in terms of times and costs) and application limits.

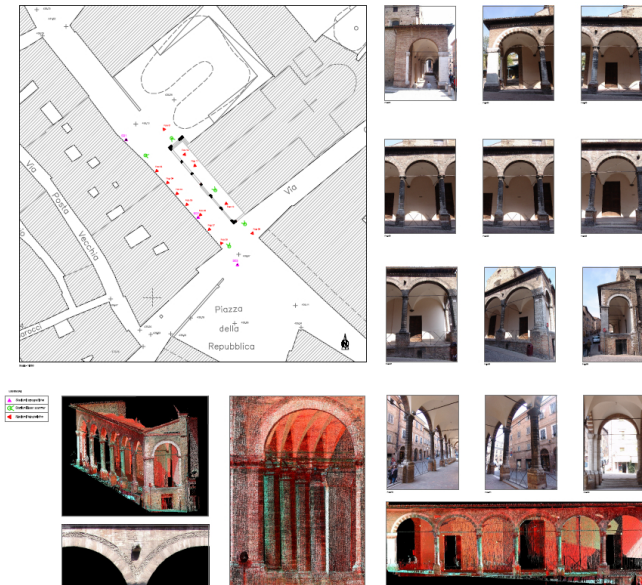
Figure 2: Survey Phase

Architectural findings were measured above all by means of two techniques which are widely used in indirect surveys: total station and monoscopic photogrammetry

2) Sony non metric camera, specifications: DSC-F828, Zeiss lens, focal length adjusted at 4.44 mm and 8 Megapixel sensor. The topographic survey of the three facades was carried out with the same number of stations (S1, S2, S3) for a total of 62 points.

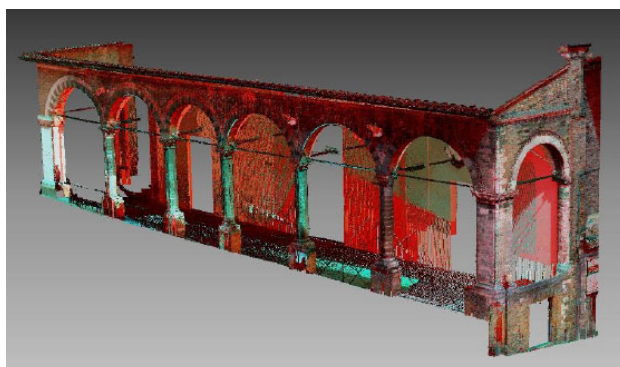
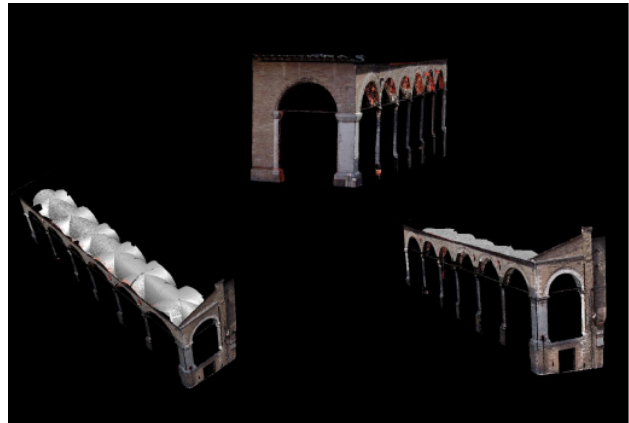
Figure 4: Survey Phase: laser scanner post processing: surface model and mapped model

The point clouds obtained by laser scanner were initially imported and read with RapidForm, and then exported to Z-Map in .ply format where they were georeferenced on known topographic points, since the first software did not make it possible to georeference point clouds but only the surfaces. The georeferencing output data obtained showed an average error below 3 cm. The clouds were then again imported to Rapidform where they were cleaned and filters applied, producing a mesh of small sections which were then joined and mapped. Despite the three-dimensional elements present (columns and capitals), the 3D model produced was acceptable, excluding those parts where due to objective problems (pedestrian traffic and parked vehicles) it was not possible to obtain sufficient data.
