MEDIEVAL GRAVE FRESCOES IN THE SOUTHERN NETHERLANDS AND BRUGGE

C. L. Williams

Roosevelt Academy Middelburg: P.O. Box 94, NL 4330AB Middelburg, The Netherlands

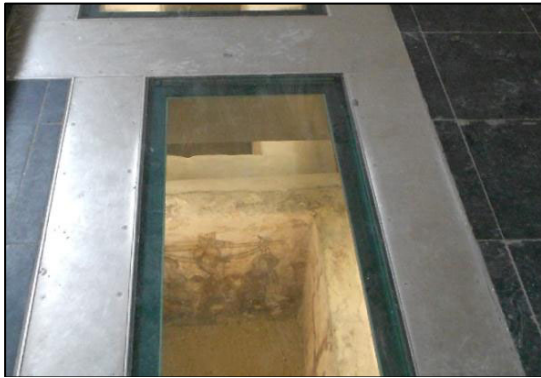
Figure 1: Glass flooring in St Salvator Church, Brugge.

Of all the cities that house grave frescoes, Brugge is the largest with 16 grave locations (Information boards St Salvator Church, 2011). It was likely the centre of this medieval practice due to its role in communication with surrounding areas. Further locations are known in Zeeland, Utrecht, South-Holland, North-Holland, North Brabant, Gelderland and a few in Germany and France. Almost nothing is known about how and why this practice spread to these regions. After excavations between February and May 2011, Brugge has the most recent information, and most effective display methods [Fig. 1].

The St Salvator church is filled with almost countless graves, but only four have frescoes. The four graves are permanently excavated, and are prepared for mass public viewing. The graves' walls are clean, often with a layer of new cement along the top of the walls for stability. The human remains are still under the layer of sand. They are still underground at their original depth, with a glass layer added above which can be walked on. Underneath the glass, light makes the graves visible. Results presented to the public via A0 posters in 2011/2012 in the church provided interesting interpretations of the grave fresco imagery. Due to the Franciscan influence the imagery is linked back to the name of the church. Christ is argued to be presented as the suffering Christ, and when with the globe, as *Salvator Mundi* - the blessing Christ [Fig. 2].

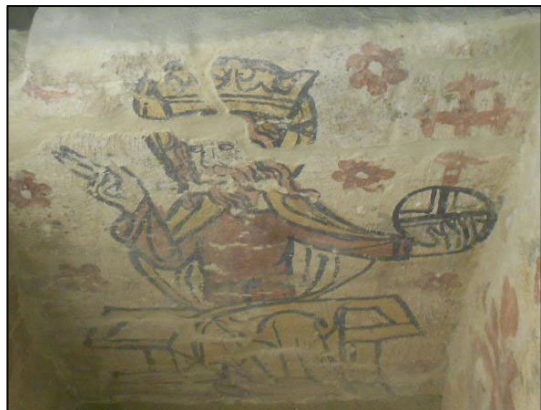
Figure 2: Blessed Christ, St Salvator Church, Brugge.

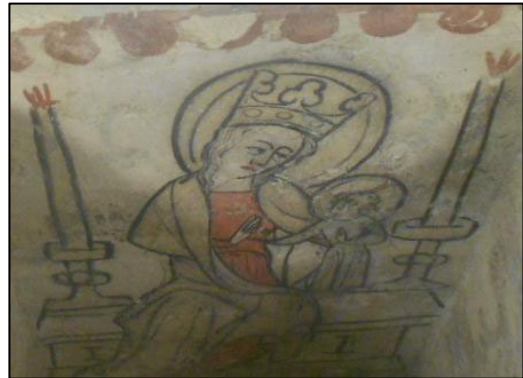
Mary is seen as the queen and mother or *advocate nostra* – the advocator and mediator in heaven who pleads the salvation of the dead [Fig. 3] (Information boards St Salvator Church, 2011). This is interesting, but only analyses the graves within the context of the church.

Figure 3: Throning Madonna with Child, St Salvator Church, Brugge.

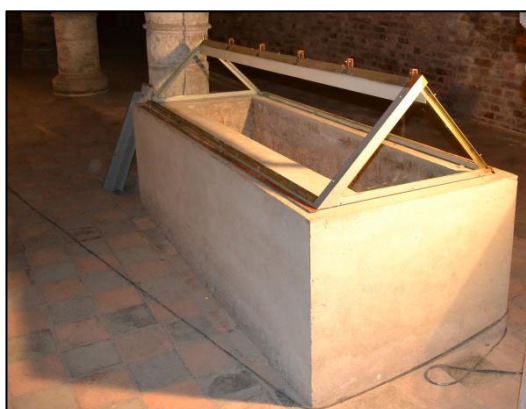
Figure 4: Grave 2307-1 with glass casing, Middelburg.

In Middelburg the condition of the painted surfaces is not consistent for all nine fragments, and a general conservation investigation needs to be completed for all. To begin with the first grave of four paintings: despite being protected by a glass layer the general condition of the painted surface is poor. There is much flaking, a large proportion of the surface is completely lost and has been filled with cement. There are large gaps where both mortar and plaster are missing showing a lack of cohesion between all layers, not just the paint and lower foundations, though this dominates. Air from the surrounding damp crypt has access to the grave via six small pipes along the long sides of the grave. However, this is not the original grave location; it is inaccessible to the public, and detrimental to the survival of the graves. As a result a new display area would be ideal. Investigation could be undertaken for them to be housed in other Middelburg locations such as the Provincial Museum, or another monumental building like the Nieuwe Kerk, both of which are popular visitor locations and only metres away from the Abdijplein crypt.

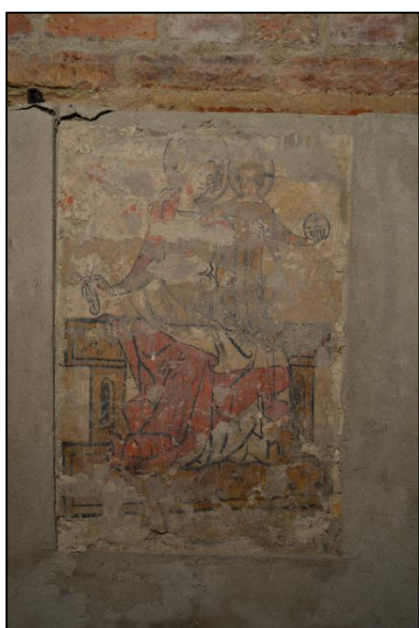
Figure 5: Fragment 2307-2a without casing, Middelburg.

The second group of fragments is generally in much better condition than the first, although almost an entire half of one is lost. They are kept in an airtight display case which is fortunate due to the damp air in the larger room housing six of the fragments. There is evidence of past treatments, because of the shiny transparent surface. Damage can be seen

in a spider's hole, a cracking in the more recent concrete casing, and salt blooming. Overall, the first painting, [Fig. 5] has much better cohesion between all painting layers, while [Fig. 6] is half lost, and with much flaking. Since these two frescoes are likely traceable to the Sluis St Peter's Church excavation, it could be a good idea to relocate the graves to the Sluis Museum that currently houses a number of frescoes from the same church excavation. Sluis is still part of the area monitored by SCEZ.

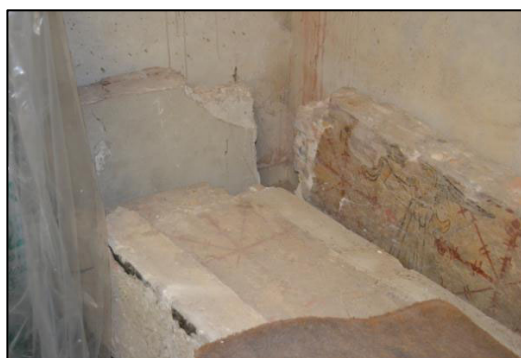
Figure 7: Grave walls 2307-3,4&5, Middelburg

The third group of frescoes is unfortunately located in an empty corner of a passageway in the same crypt between the Abdij market entrance, and an elevator. It is subject to much foot-traffic, artificial lighting, dust, and they are grouped with a lot of other storage material. One wall is facing upwards, another has its painted surface half hidden behind the first as it faces into the room, and the third is completely facing the wall. Its pictorial content is to this day unknown. Considering dust, debris and paper had to be swept from the painted surface to allow for documentation, these also need urgent relocation. Without more information about their origins, a new location in Middelburg would be best. Including company commission, the initial treatments, checks and relocations of these graves would cost over €9,000 before adding necessary equipment, transportation machinery, or the cost of additional actions recommended during the Conservation analysis.
